# Holzlabor

23. August 2004

## Research report Fregata D. Fernando II e Glória

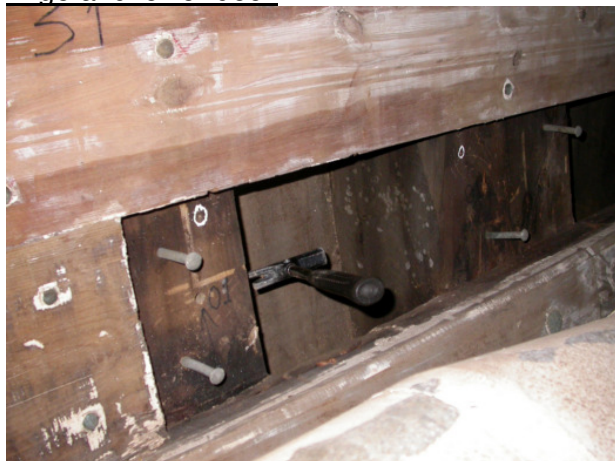
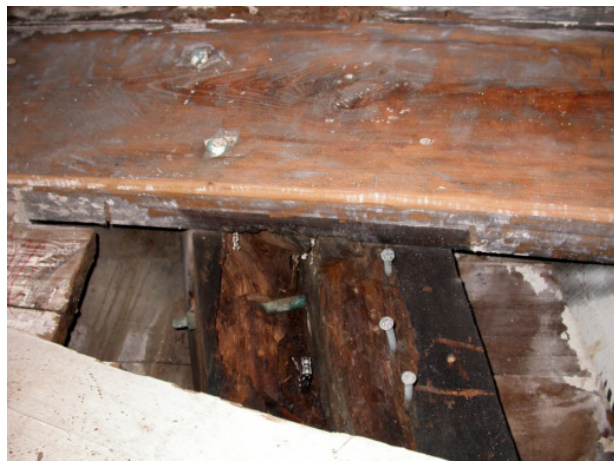
Fig. 3+4. Details of the construction of the hull: Rafters approx. 26\*26cm covered on both sides with planks of approx 8cm thickness. Distance of rafters approx. 40cm.

Throughout the whole ship the same situation was found (Fig. 3+4). Some decayed structural elements were detected (Fig. 5). The decay was mostly associated with parts of less durable pine wood where even the suspicion is probably that sapwood that has no natural durability was used. Wood of Pine, Oak (obviously Cork oak) and Teak were used. Taking into consideration the situation of the partly destroyed vessel before its reconstruction in 1992 (Fig. 6) this mixture and combination of species in the wooden structure is not surprising.

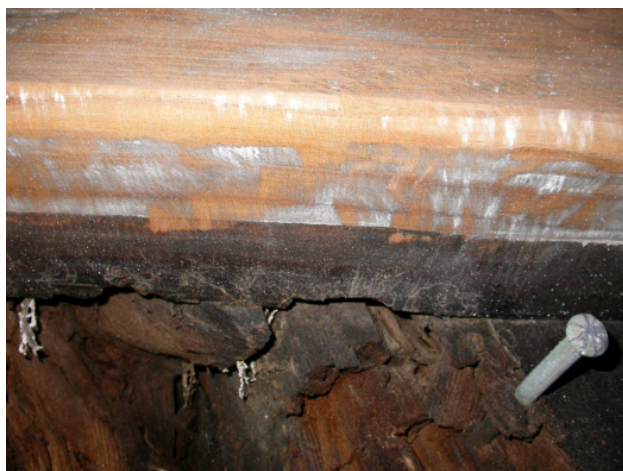
Fig 5 (left): Deteriorated rafter in the back

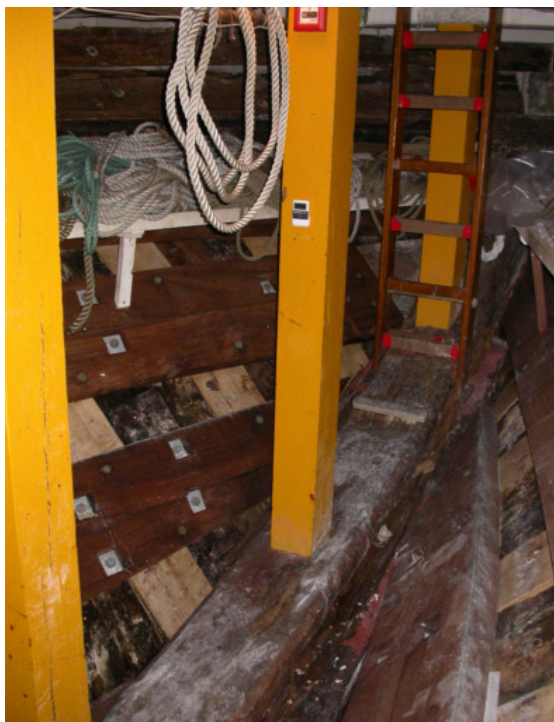
Moisture measurements (oven drying) were taken out on several specimens in the INETI laboratory. Sound wood showed a humidity of approx. 20-24%, but deteriorated wood raised up to approx. 80%. The air humidity was with 60-70% r.h. and a temperature of approx. 25°C (Fig. 7+8) well established and controlled by condensation air-dryers (Fig. 9)

Fig. 7: (left) Bow-room. Traces of floating water are visible but know the wood is at acceptable equilibrium moisture. Some deteriorated rafters are replaced by laminated and on site glued wood that is unfortunately of Spruce (*Picea ssp.*) with no natural durability (!).

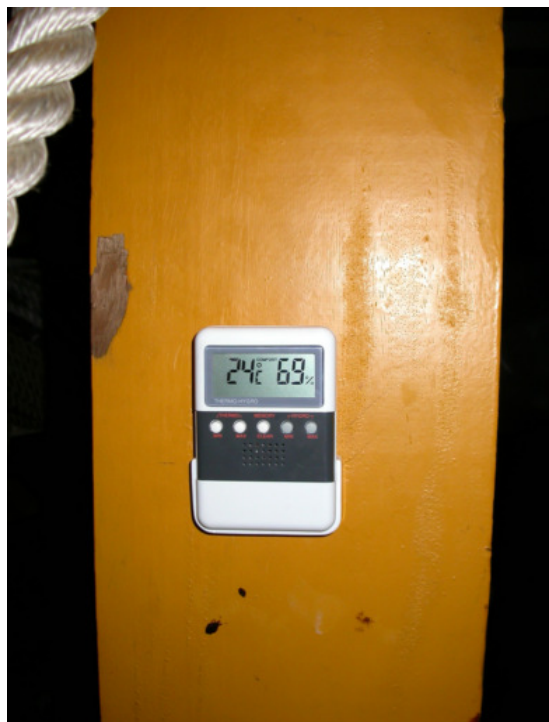
Fig. 8, (right): Detail: Air humidity is controlled continuously.

① Continuous control of the humidity of the air. If necessary ventilation.

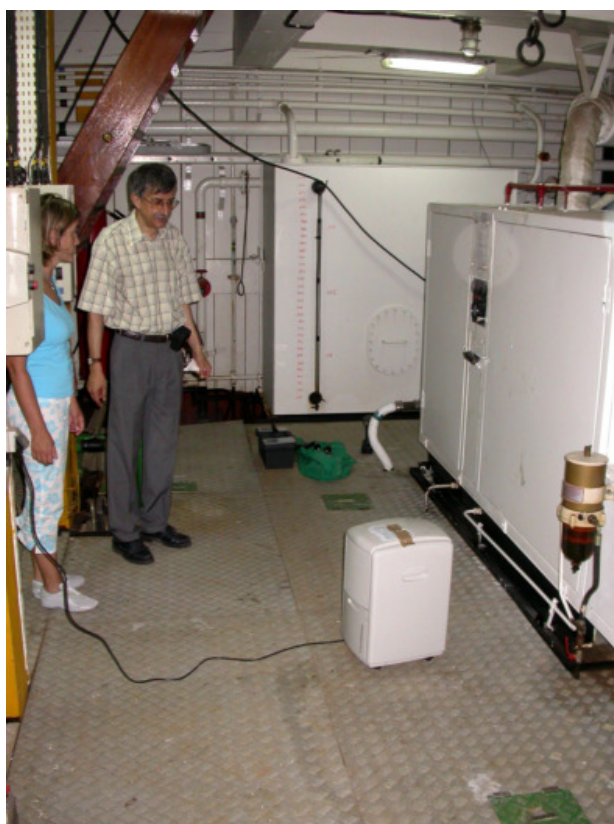
Fig. 9: condensation air-dryer in the technical room in the middle of the vessel.

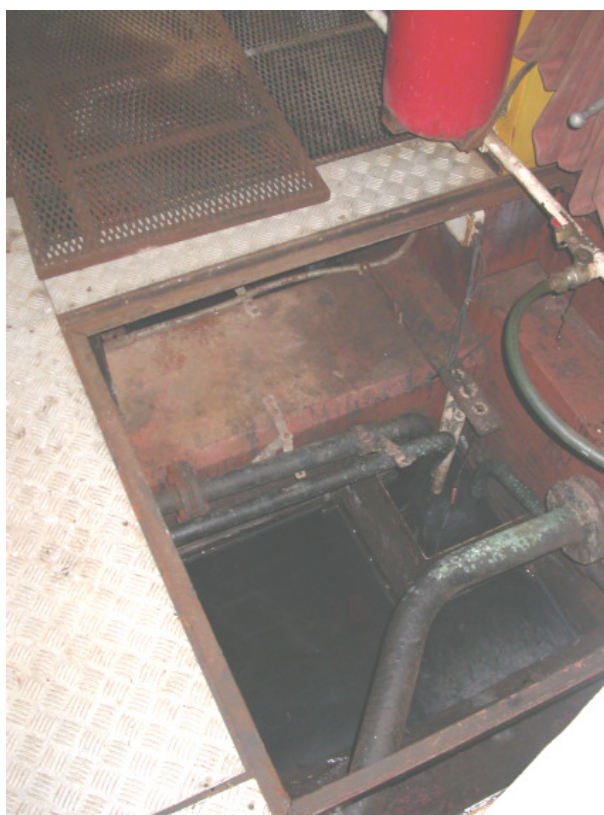
Fig. 10: Bilge below the technical room: Water is continuously standing at the keel which is normal for any vessel. No signs of decay were found.

The high natural durability of the original Teak wood can be demonstrated on the upper keel in the bilge (Fig. 10): No signs of decay are detectable although the wood is in continuous contact with water.

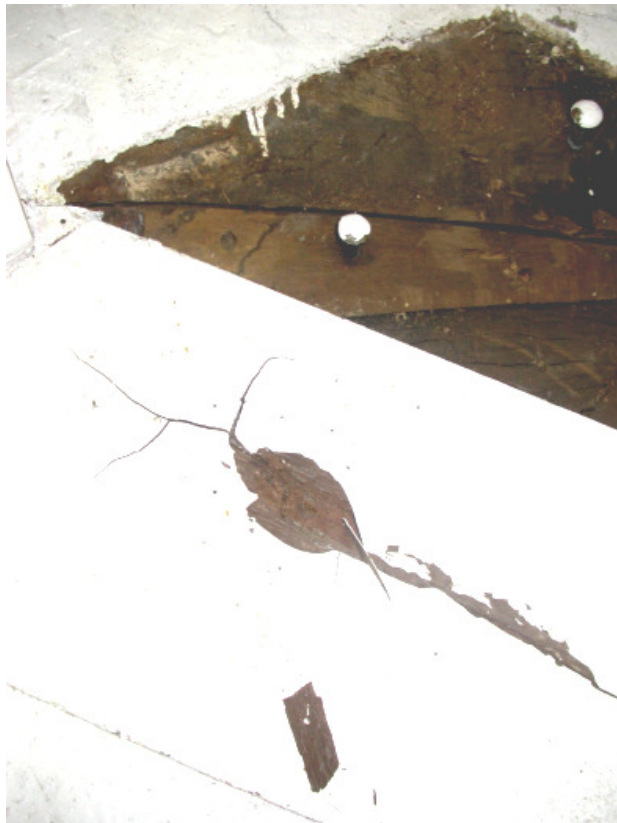
The paint forms a thick coat on the surface preventing the evaporation of water penetrating the wood through natural cracks (Fig. 11). This effect can be studied on Fig 11: The crack on the surface resulting from a not, thus a natural structural defect, allowed water to penetrate in the wood. The paint prevented the evaporation resulting in decay around the not. Unclear is the source of the water. It must have been running down the planks after they were painted. It is the most probably explanation that this decay was initiated even at the shipyard at the reconstruction in 1992.

Fig 11: Decay in the painted planks

② Removal of all paint coatings in the lower part that could be wetted by the water from the river penetrating through the hull. It is recommended to keep free an area aprox. 1/2m above the outside copper plates. (compare yellow lines drawing p.7).

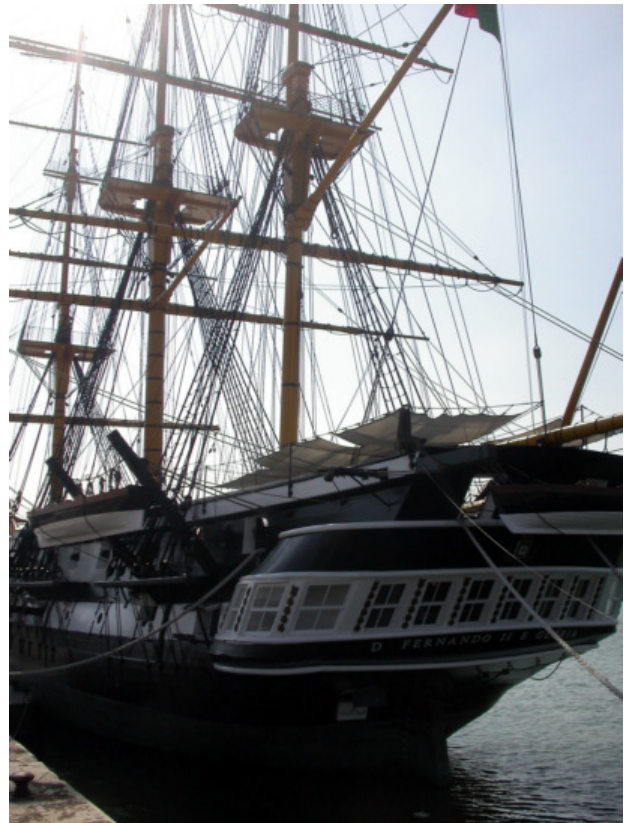
Decay at the windows of the rear part have the same reason: Uptake of water but no or only slow drying due to coatings in combination with less durable wood species or parts of wood (Fig. 12).

Fig. 12: the highly structured rear part gives many water traps.
