# Holzlabor

23. August 2004

## Research report Fregata D. Fernando II e Glória

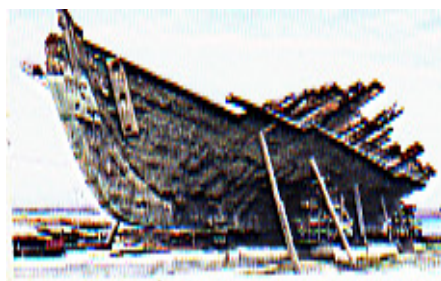
Moisture measurements (oven drying) were taken out on several specimens in the INETI laboratory. Sound wood showed a humidity of approx. 20-24%, but deteriorated wood raised up to approx. 80%. The air humidity was with 60-70% r.h. and a temperature of approx. 25°C (Fig. 7+8) well established and controlled by condensation air-dryers (Fig. 9)

Fig. 7: (left) Bow-room. Traces of floating water are visible but know the wood is at acceptable equilibrium moisture. Some deteriorated rafters are replaced by laminated and on site glued wood that is unfortunately of Spruce (*Picea ssp.*) with no natural durability (!).
